Building Stability Report

256 Main Street, Berlin New
Hampshire

Prepared by :
Toufic Awad

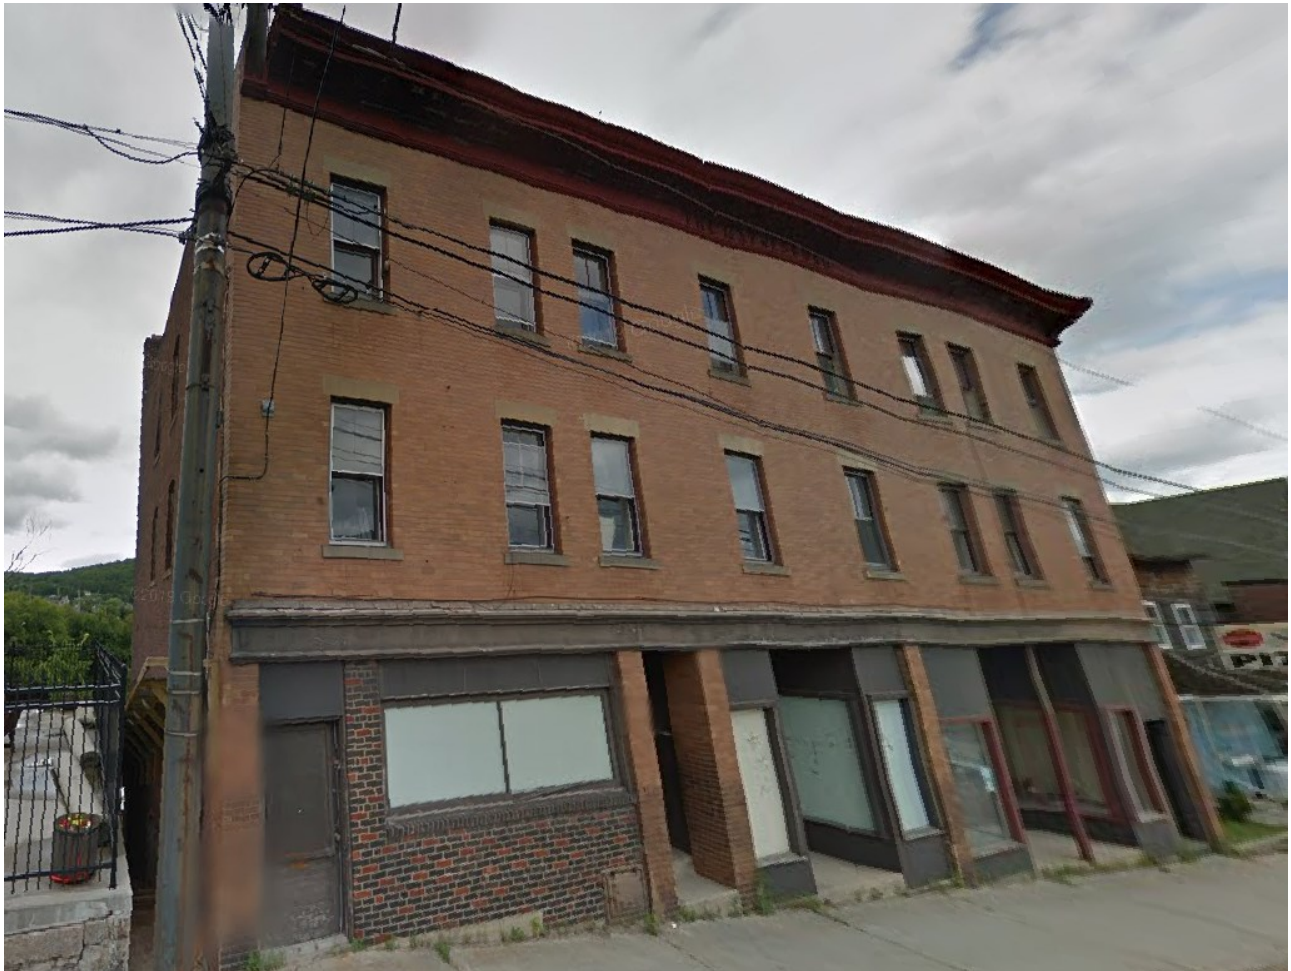
Figure 1.2: Front Elevation of the Building

The building is described as a three-story residential structure with a basement and two additional levels (refer to Figure 1.2). The exterior walls predominantly consist of brick, while retaining walls are constructed using sandstones. The basements feature concrete slab-on-grade construction, while the upper levels and roofs are constructed with timber framing.

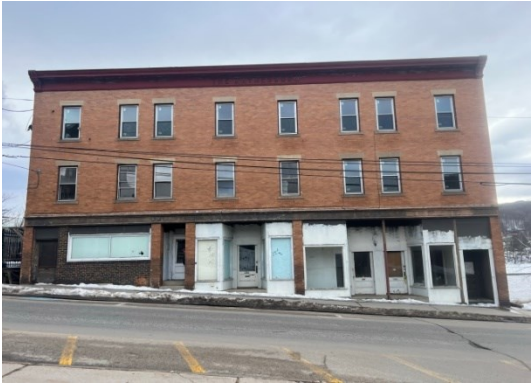
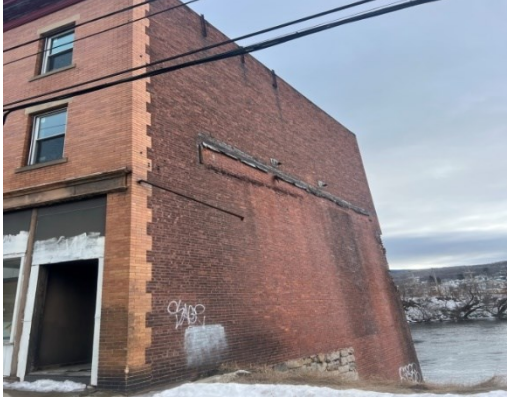
Observation: Building Front Elevation	Observation: Building Side Elevations
Additional Comment(s) (if Applicable):

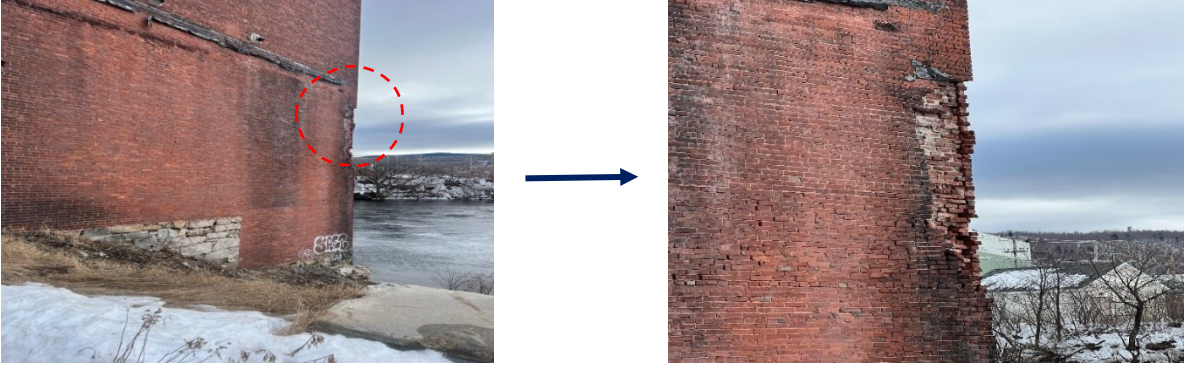
Observation: The exterior wall has incurred significant damage, which has consequently compromised the lateral integrity of the building.
Recommendations: The damaged areas of the brick walls will be reconstructed without compromising the stability of the existing building.

1. The entire damaged floor framing and sheathing system will require replacement as part of the floor structure replacement.
2. All damaged brick wall portions shall be constructed as per local building standards.
3. All corroded steel sections shall be repaired as per the recommendations.

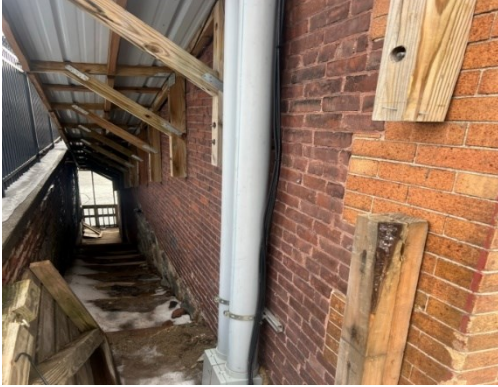
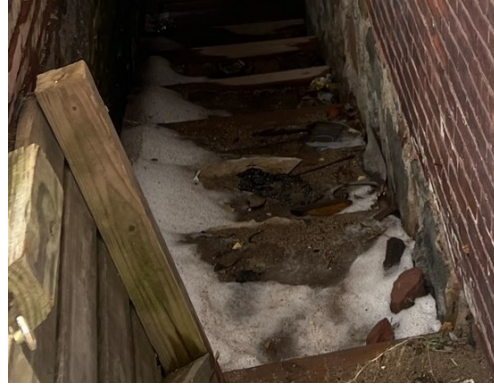
Observation : Stairways of building Seems to be Slippery

Recommendations : Evaluate the possibility of replacing the current stairway surface with materials that offer better slip resistance, such as rubber or textured surfaces.

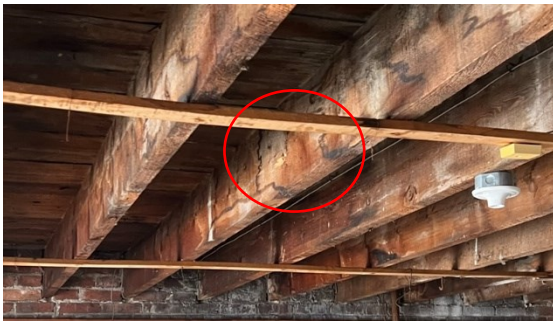
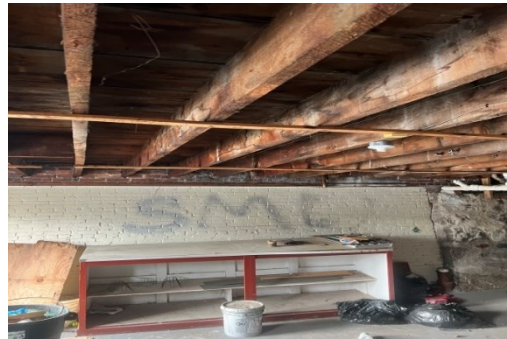
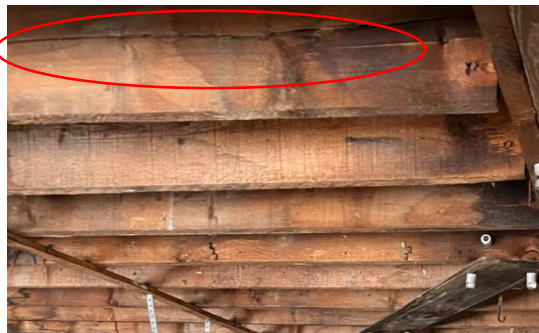
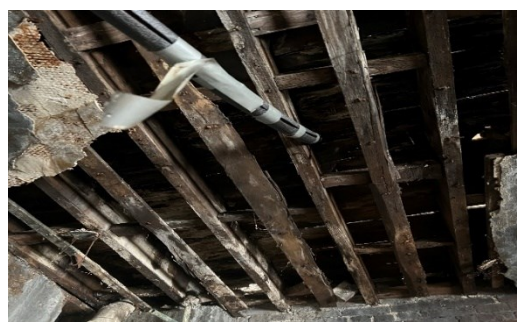
Observation: The existing floor joists have observed significant cracking and deterioration.

Recommendation: It is advised to install new floor joists throughout the entire area to mitigate the risk of hazardous damage.

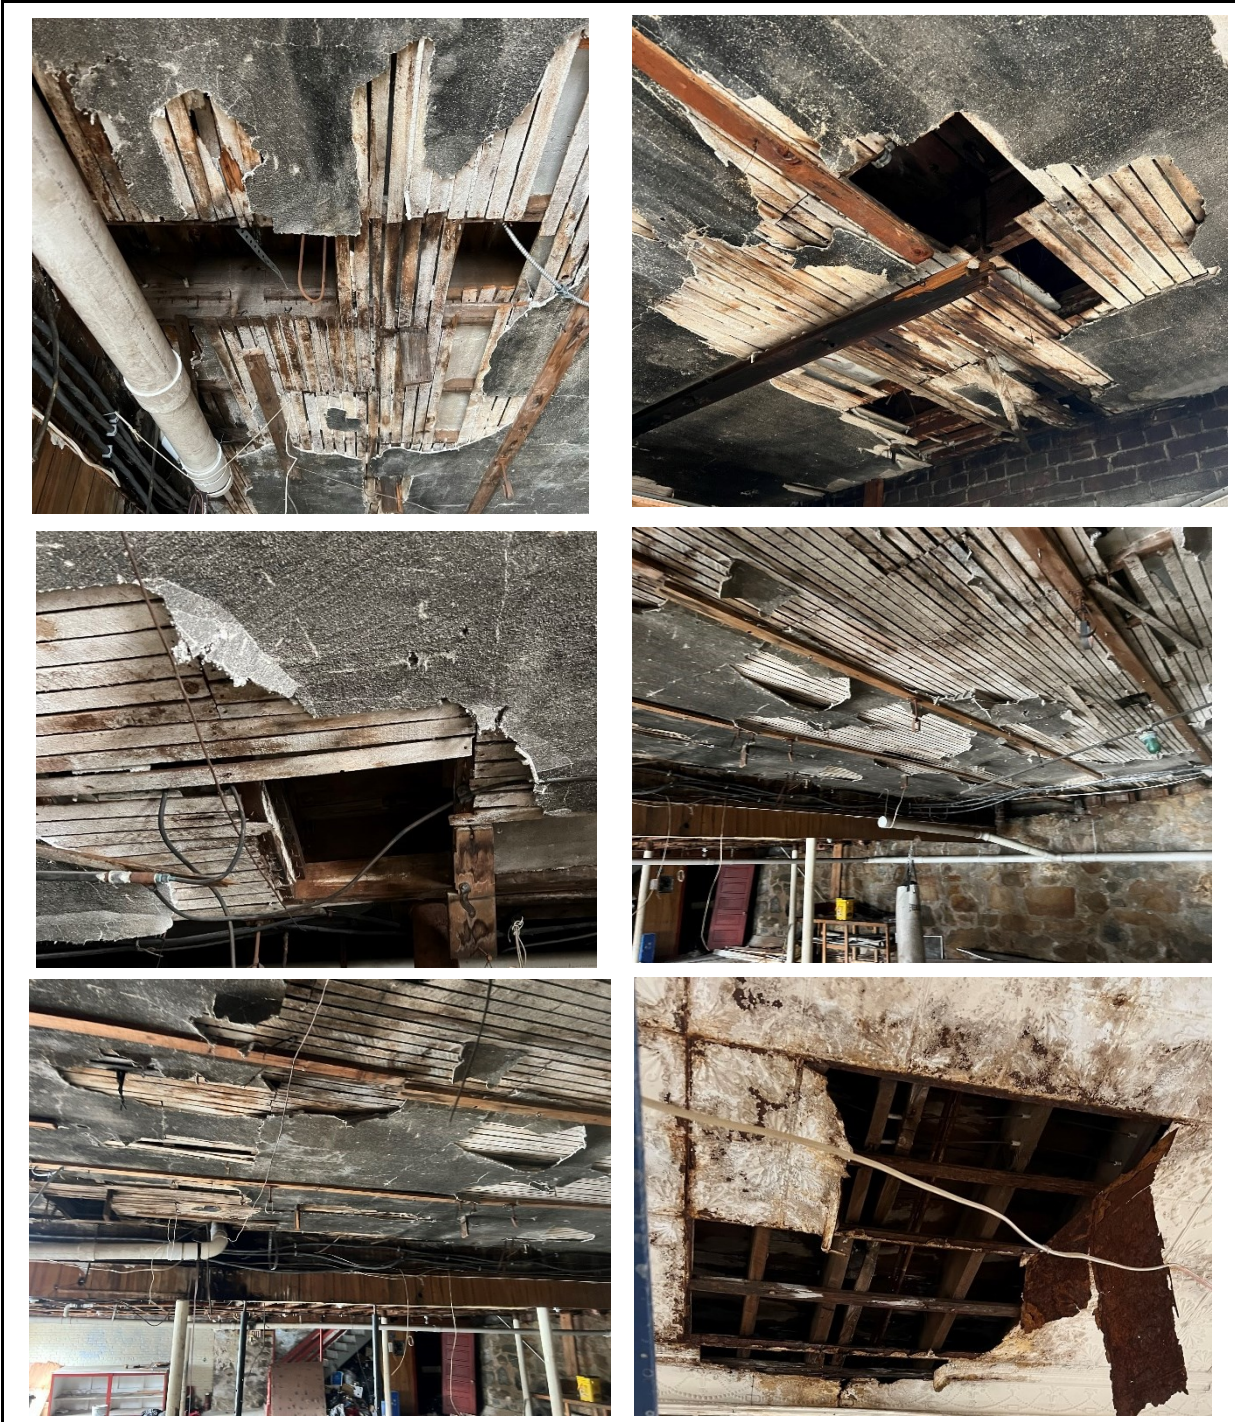
Observation: The existing ceiling joists and sheathing have undergone substantial deterioration.

Recommendation: It is advised to install new ceiling joists throughout the entire area to mitigate the risk of hazardous damage.

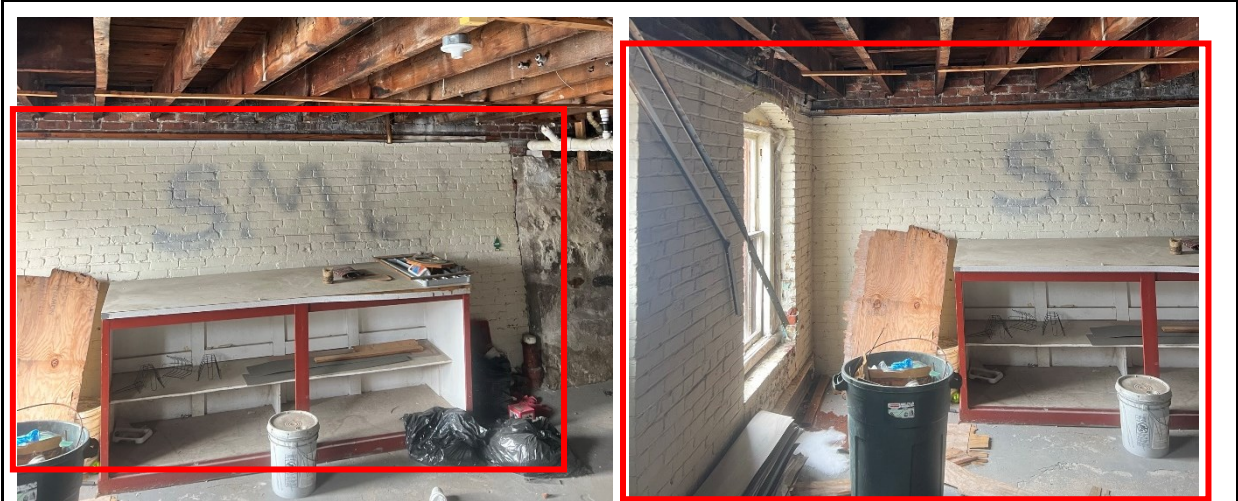
Observation : The exterior brick wall should be utilized as a shear wall to provide lateral stability for the building.

Recommendation : There was no significant damaged were noted on the brick walls

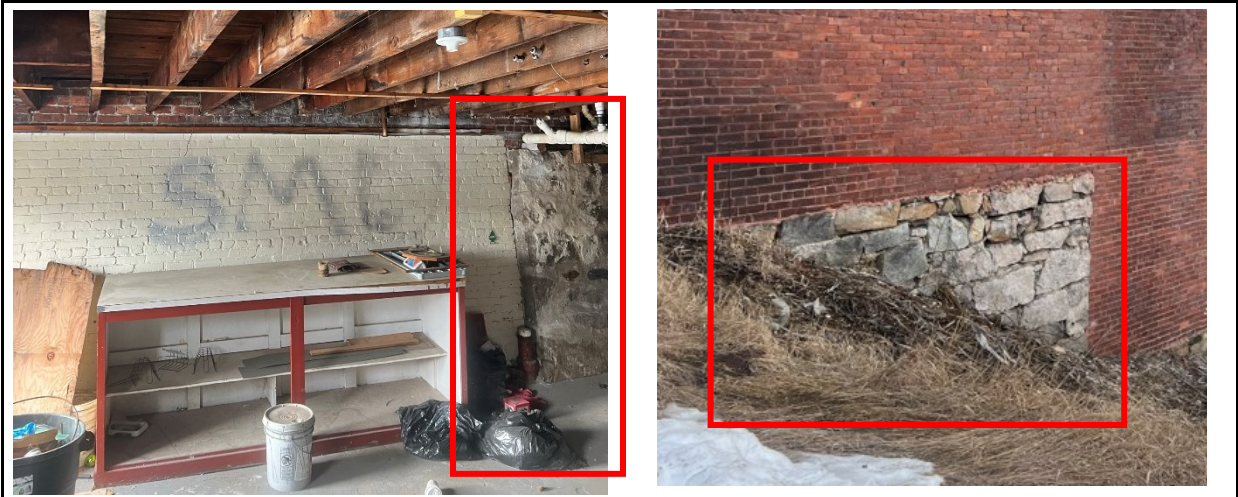
Observation : Sandstones are utilized as the material for the retaining walls of the building.

Recommendations : There was no significant damaged were noted on the Sand stones

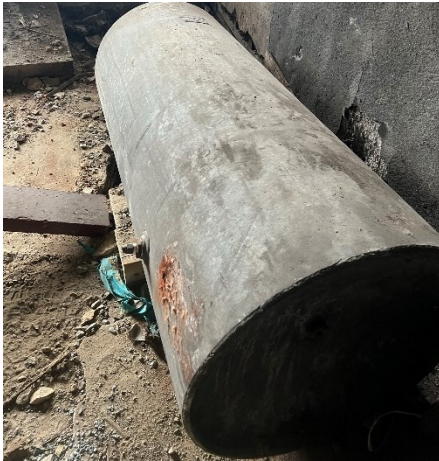
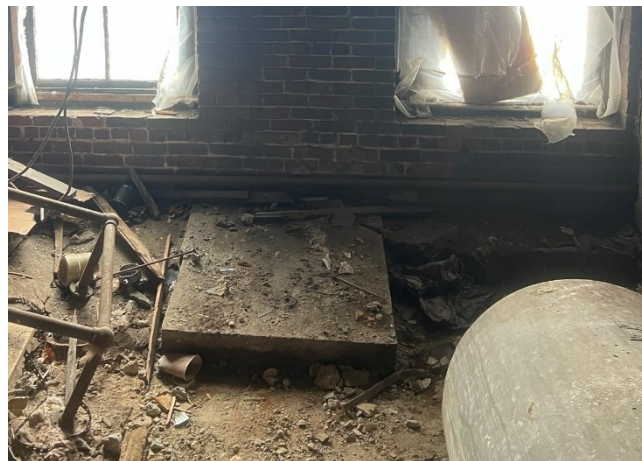
Observation : This appears to be a tank or a similar structure, found in the basement area

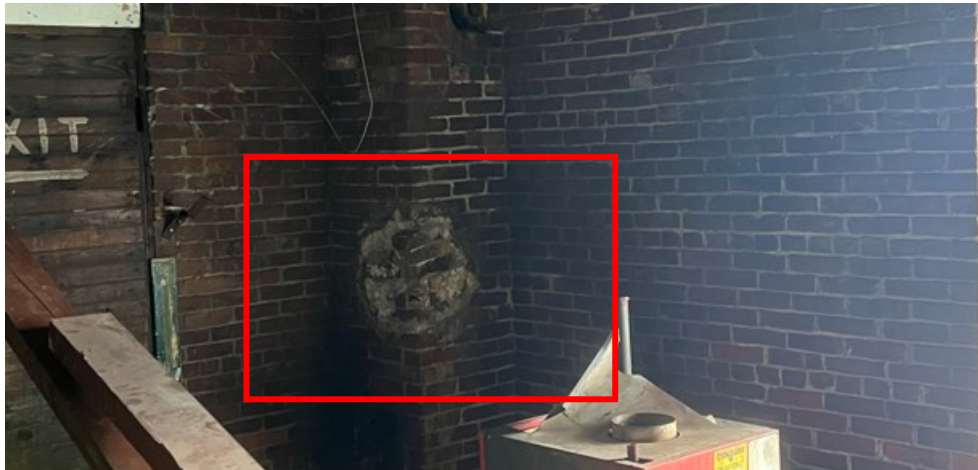
Observation : Significant damage was encountered in the load-bearing corner wall/column of the building, which has affected the gravity load path of the structure.

Recommendations : The damaged areas of the brick column/wall will be reconstructed without compromising the stability of the existing building.

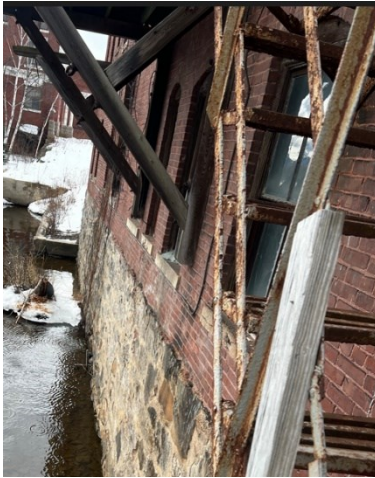
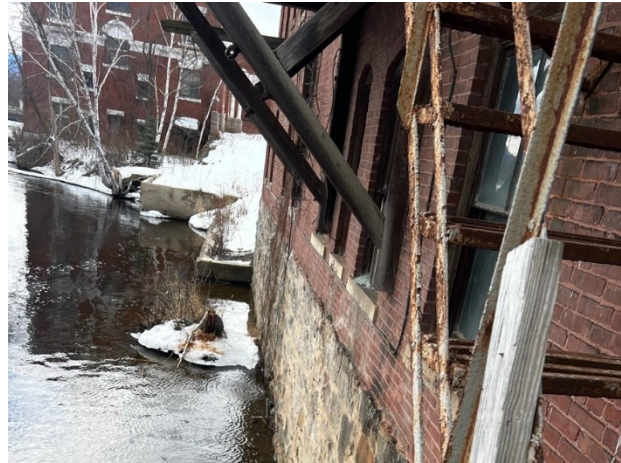
Observation: Significant corrosion was observed at steel angles at rear side of the building

Recommendations : The corrosion should be removed down to the bare steel surface, followed by repainting the entire affected area of the steel.
